PV SYSTEM DOCTOR

PV SYSTEM INSPECTION & FAULT DIAGNOSIS SPECIALIST

50 - 100 kWp

SINGAPORE

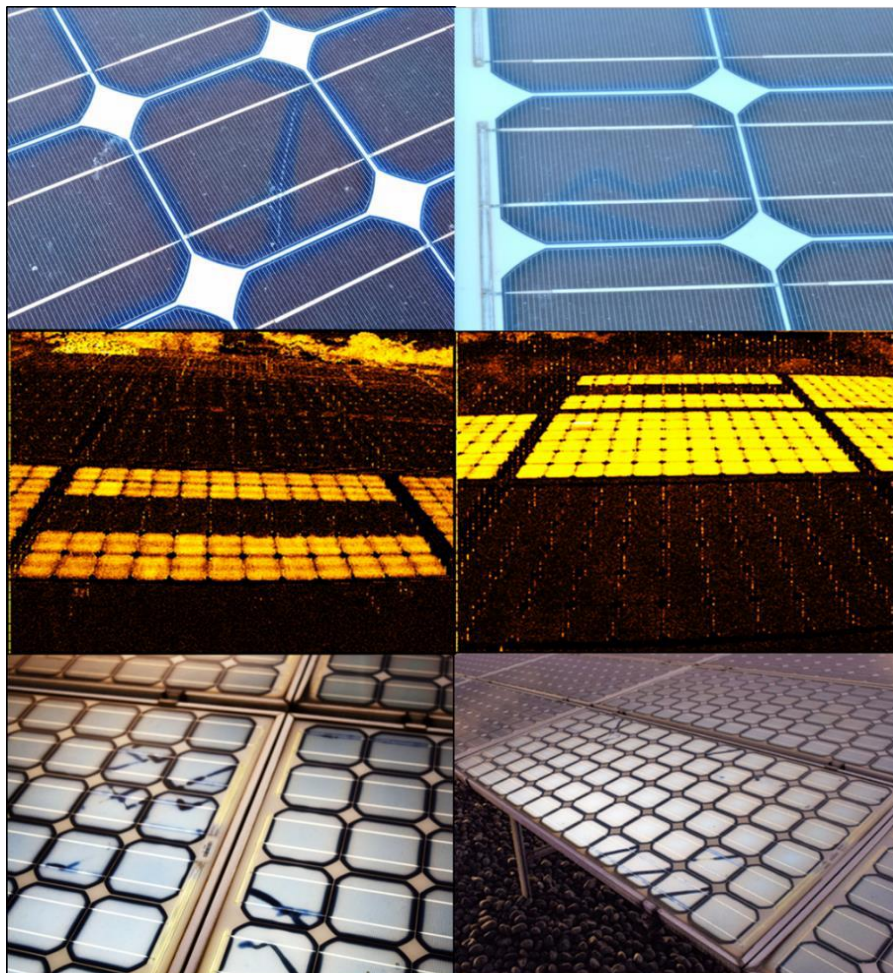
Module defects:	Bypass diode failure, Backsheet burn marks, Snail trail, Micro-cracks
BOS faults:	Inverter failure, Cable faults

On site-inspections revealed that the complete PV system was not operating. Upon investigation with unique imaging techniques, the team was able to successfully identify the defective modules. The modules were pre-dominantly affected by snail trails and micro-cracks. Bypass diodes failures and back sheet burn marks were also observed. Equipotential bonding of extraneous conductor (modules frames) was also found to be missing. AC cable faults and non-functional inverters were also found to cause the PV system to be not operating.

SERIS helped to identify the fully-functional modules that could be re-used on the refurbished PV system. It constitutes approximately 85% of the initial PV system installed capacity. A detail refurbishment plan for the PV system was presented to the customer.
