# PV SYSTEM DOCTOR

10 – 50 kWp  
INDONESIA

Solar Energy Research  
Institute of Singapore

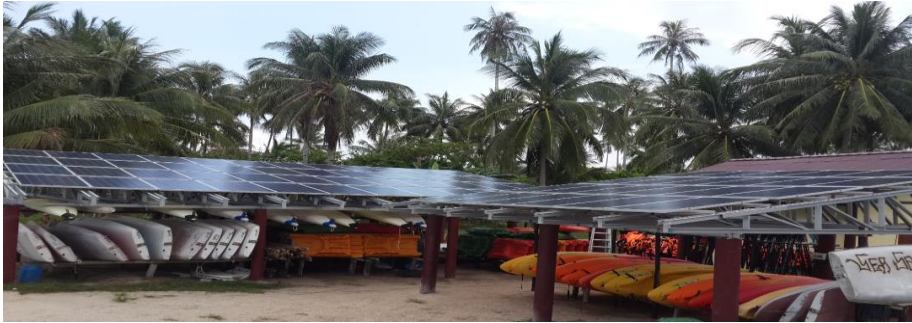
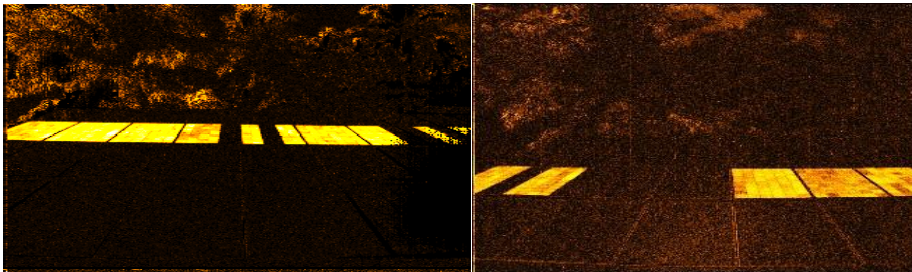
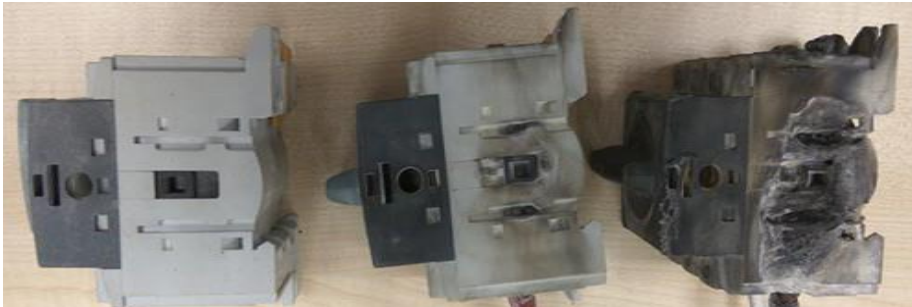
On-site inspection revealed that close to 40% of the PV system was not operational. Upon investigation, it was revealed that the bypass diodes were short-circuited due to lightning strikes. Moreover, one of the string inverters was not working. Connectors were found to be burnt and DC disconnectors not capable of arc suppression were also found to be used.

SERIS helped to identify faults in the system and help to reinstate the expected PV system performance. The bypass diodes were changed in all the faulty modules. Lightning rods were installed near the PV system, and all the modules frames were earthed to the system structure. A potential safety hazard (DC arcing) that could lead to a fire accident was resolved. The team also helped to claim faulty string inverters within the manufacturer's warranty period and to replace the DC disconnectors.
